A1E Project No.21-7102

December 14, 2022

Re: Roof Deck Distress Assessment & Recommendations – Proposed Scope of Services

Olmos Towers
700 E Hildebrand
San Antonio, Texas

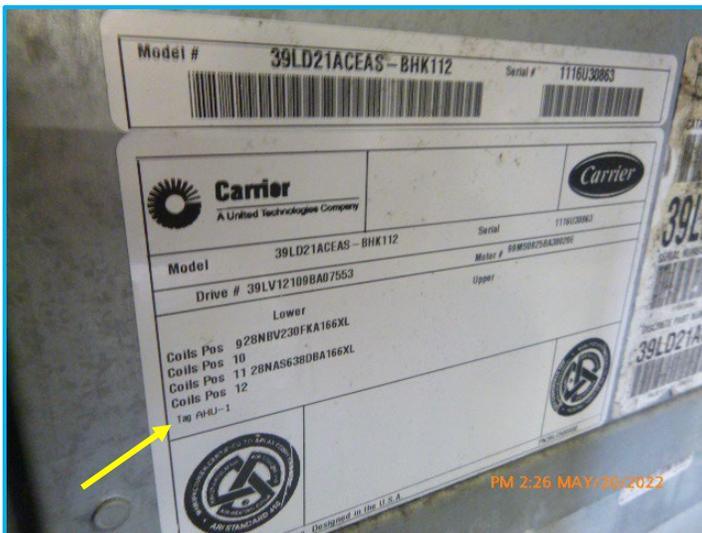
The Carrier air handler (SN: 1116U30863 – See Photo #1 & #2), hereafter referred to as AHU-1, was located at the west end of the mechanical penthouse. The AHU-1 is supported above the concrete roof deck on a steel frame with a galvanized sheet metal drip pan below the air handler (See Photo #3) that prohibits the surface of the concrete roof deck from being viewed. Adjacent to the VFC-3000, the exposed concrete roof deck exhibits spalling where strips of concrete have delaminated from the reinforcing steel (rebar) due to expansion of the corrosion as the rebar is exposed to water, apparently due to leaking pipes above (See Photo #4). Water from the leak is currently being collected in a plastic trash can (Review Photo #2).

Photo 1: Air Handler at the west end of the Mechanical Penthouse marked as AHU-1

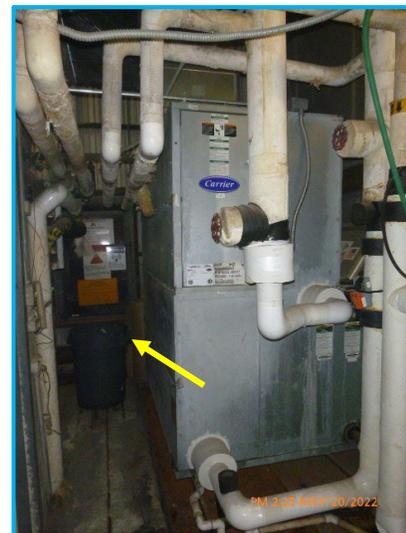
Photo 2: AHU-1 with plastic trash can below piping to collect leakage

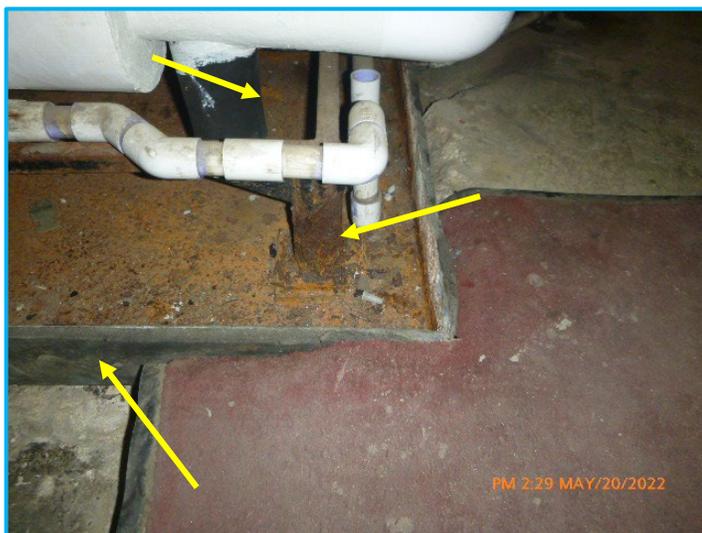
Photo 3: Galvanized drip pan and steel frame supporting AHU-1

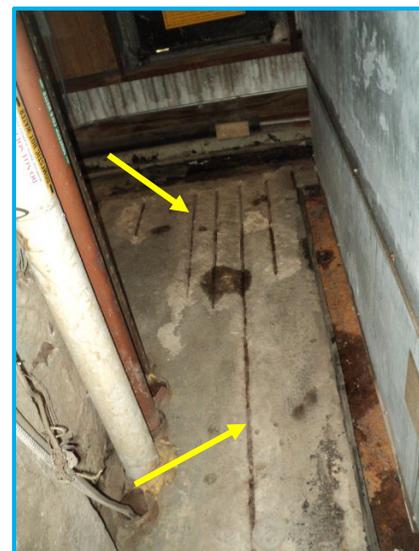
- Spalling concrete on the topside of the concrete roof deck in the vicinity (and likely beneath) the a/c equipment attributable to a leaking water line(s) has resulted in corrosion expansion of the reinforcing steel and a loss in the integrity of the floor slab reinforcing steel

Photo 4: Spalling concrete at rebar due to corrosion expansion adjacent to AHU-1

- **Addition of Supplemental Reinforcement:** The corrosion causing the spalling of the concrete near and likely under AHU-1 is extensive and has reduced the load carrying capacity of the roof deck. We recommend to supplement the corrosion attacked reinforcing steel with carbon reinforcing rods embedded into the top of the concrete roof deck. **These rods will likely need to extend PAST the west end of the mechanical penthouse and into the adjacent open roof area.** As a minimum, the concrete curb at the West end of the mechanical penthouse will need to be partially removed for access and replaced after repairs. Additionally, the roof membrane and/or insulation board outside of the mechanical penthouse West end will need to be REMOVED in order to extend the added carbon rod reinforcement

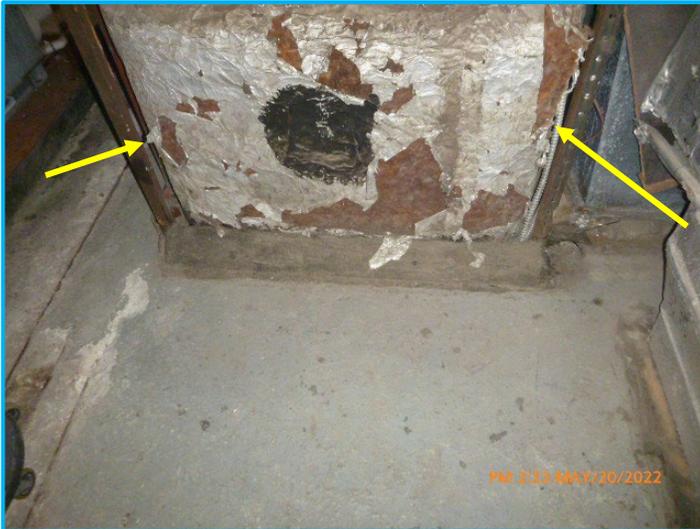
- The opening in the concrete roof deck directly against the West side of the West stairway for a large duct penetration does NOT appear on the structural drawings provided for our review. Without “As-Built” drawings or other documents verifying how this area was constructed, we cannot ascertain if the design is suitable to support code required loads. Further examination of this area is needed and will require access to Unit 1500 in order to examine construction at the duct penetration and beneath the reinforcing steel corrosion areas previously noted.

The concrete roof deck penetration at the West side of the West stairway for the large 3' x 4' air duct (See Photo #5) does not appear on the structural drawings provided for review. Less pronounced spalling of the top of the concrete roof deck was visible near the mechanical penthouse West wall (See Photo #6).

Photo 5: Duct penetrating the concrete roof deck at the West side of the West Stairway

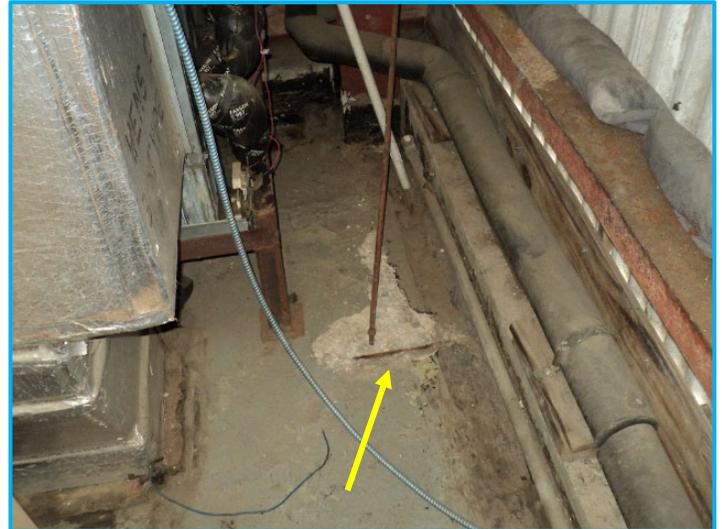
Photo 6: Spall in the concrete roof deck near the mechanical penthouse West wall

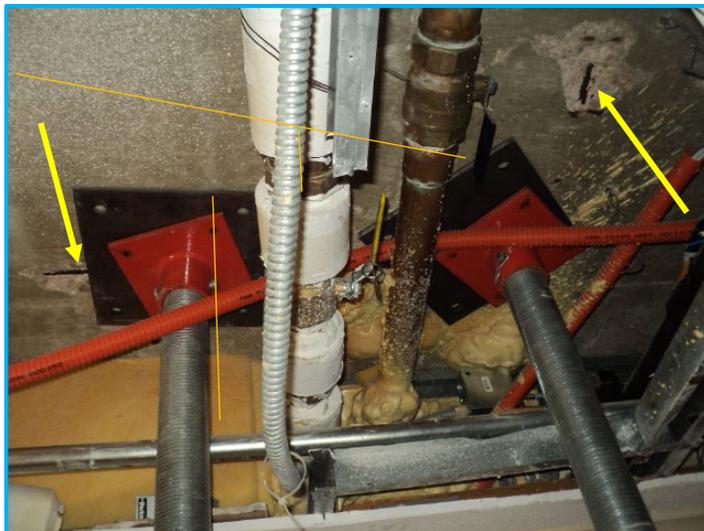
- Spalling concrete (delamination of concrete strips or patches) on the soffit (underside) of the concrete roof deck suggests that overloading of the roof deck exist due to either excessive loading and/or damage to reinforcing steel

Spalling of the soffit (underside) of the concrete roof deck was visible from the corridor outside of Unit 1501 (See Photo #7 & 8).

Photo 7: Spalls at concrete roof deck soffit outside of Unit 1501 with slight to moderate rebar corrosion

- **Repair of Roof Deck Soffit Spalls:** Corrosion of the reinforcing steel at the soffit of the roof deck appears light but enough to cause spalling of the concrete due to expansion of the lightly oxidized steel. We anticipate that repairs can likely be done by cleaning the reinforcing steel, patching the spalls with a high strength grout and possibly adding a fiber reinforced polymer (FRP) band to the spalled areas. The extent of any FRP repairs will be dependent on the structural analysis of the as-built conditions.

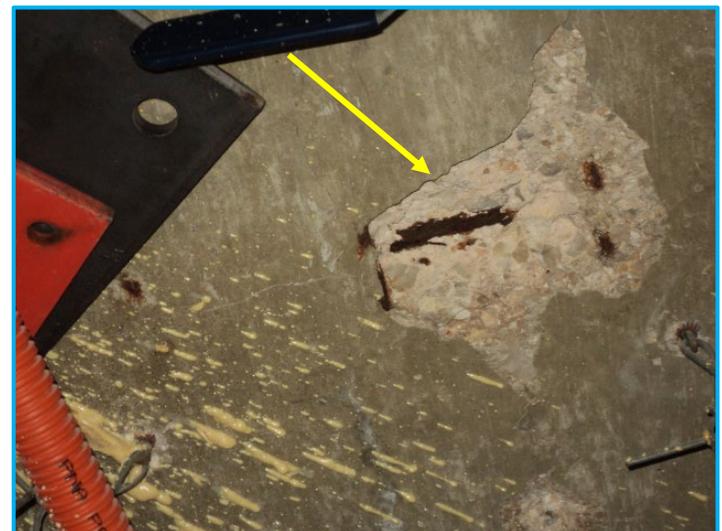
Photo 8: Close-up of spall location outside of Unit 1501

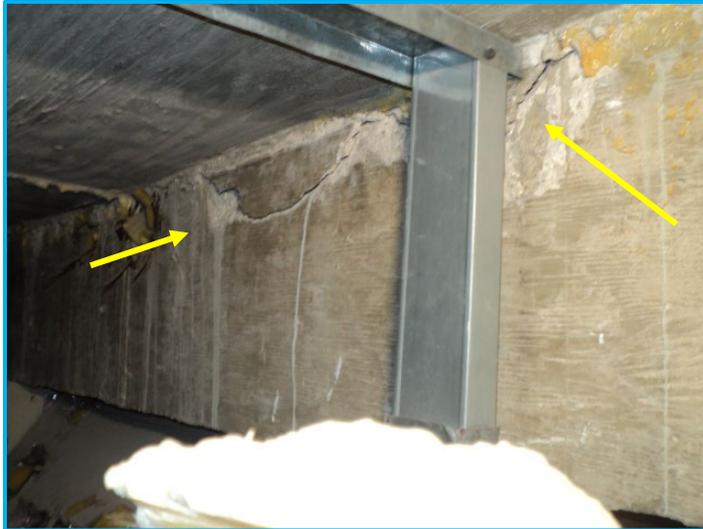
- Overloading of the concrete beam extending from the North wall of the West stairway has caused some spalling at the deck to beam interface. The beam has four (4) holes cut into it within 2’ of the stairway wall. The holes have new piping passing through and appears to have been part of an MEP “upgrade”. Shear reinforcement in the beam may have been cut. Further examination is needed.

The concrete beam (for discussion purposes identified as B-1) extending to the North from the North face of the West stairway exhibits spalling along the line that joins the slab to the beam face (See Photo #9) as viewed from the corridor closet. The end of beam B-1 adjacent to the West stairway has four (4) new holes cut for mechanical/plumbing lines. The holes were cut close to the bottom of the slab (approximately at mid-height of the beam). While this is the best height to minimize the impact on the beams ability to resist bending, placing the holes at the end of the beam reduces the beams shear capacity. Simply stated, the beam is less able to resist a sudden snap failure at this end. This reduction can be further magnified if the stirrups (vertical steel “bands”) that are installed to resist shear forces were cut. **Examination of the beam end by Ground Penetrating Radar and/or Radiography is highly recommended to gather needed information to address this modification.**

Photo 9: Duct penetrating the concrete roof deck at the West side of the West Stairway
