Re: Olmos Tower Roof Investigation

# **Structural Evaluation Report**

## ***Olmos Tower Roof Investigation 700 E. Hildebrand, San Antonio***

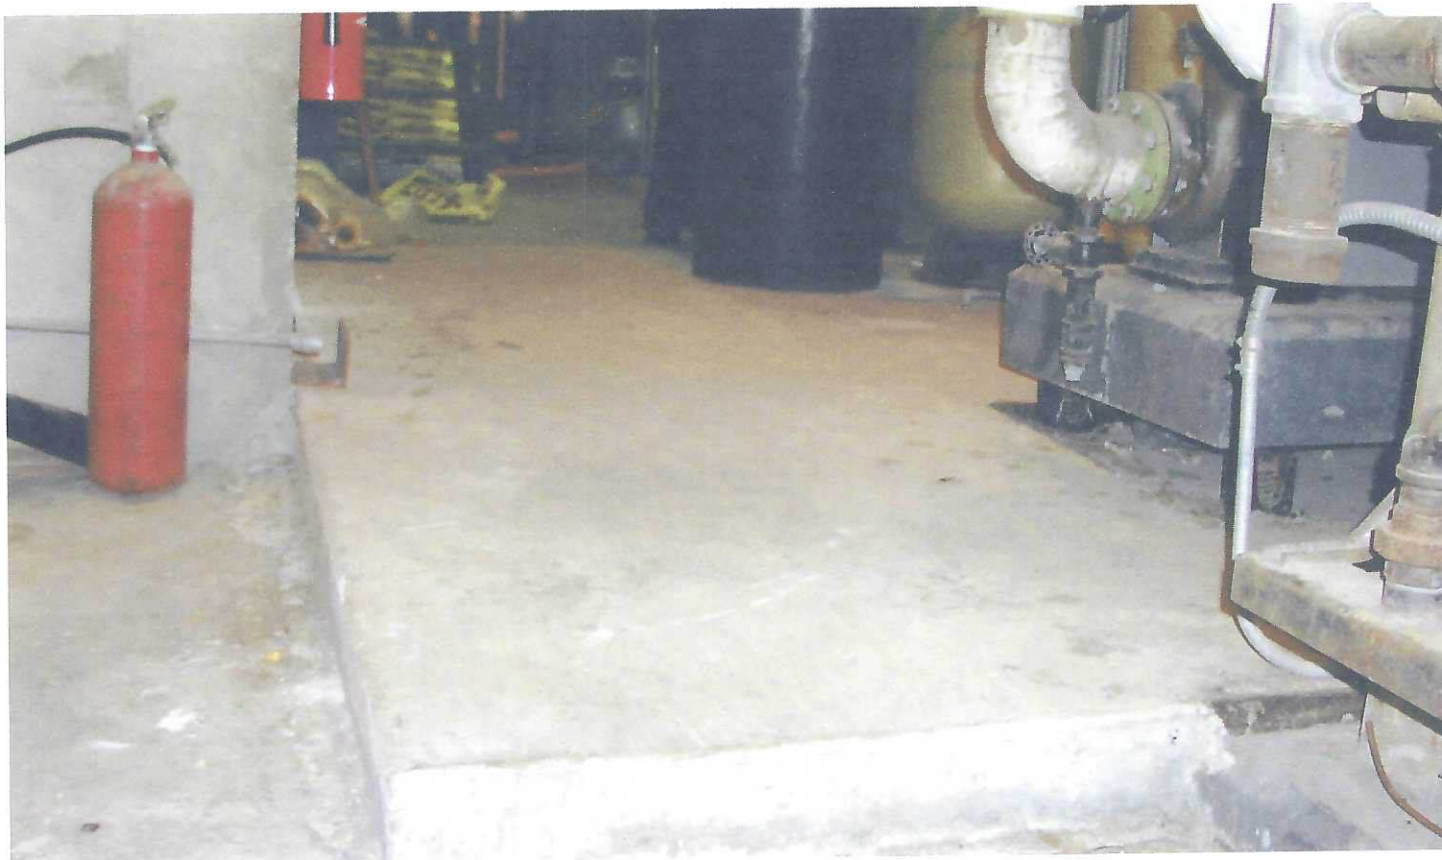
1. The new slab for the water softener covers approximately 150 square feet (SF) of the penthouse floor. It is approximately 6-inches thick and abuts the mechanical slab on the westerly end of the penthouse. (*Figs. 1 thru 4*) We do not know what reinforcing was used within the added slab.

Fig. 1 - Water Softener Slab and Equipment

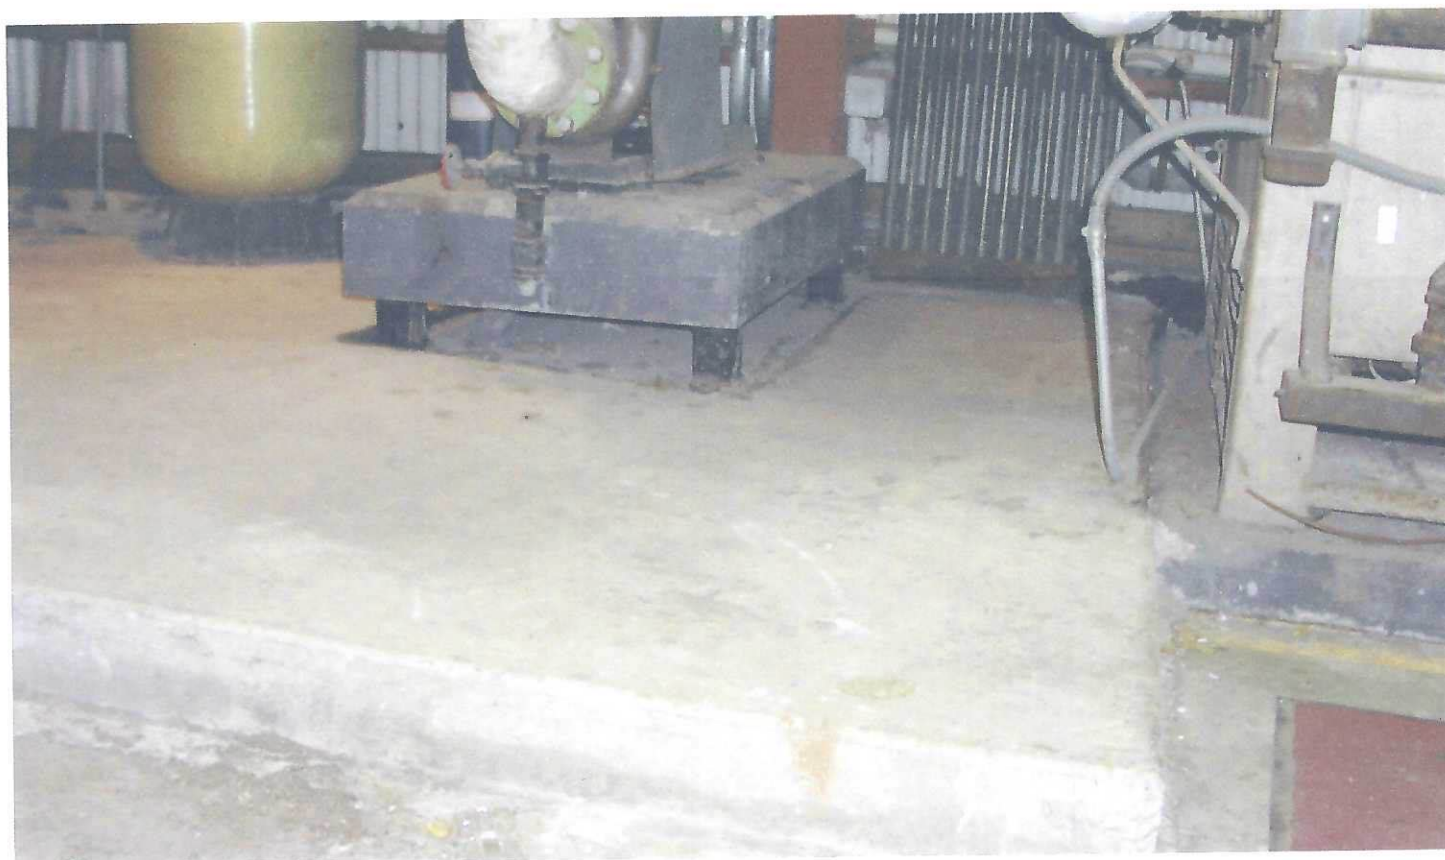
Fig. 2 - Water Softener Equipment

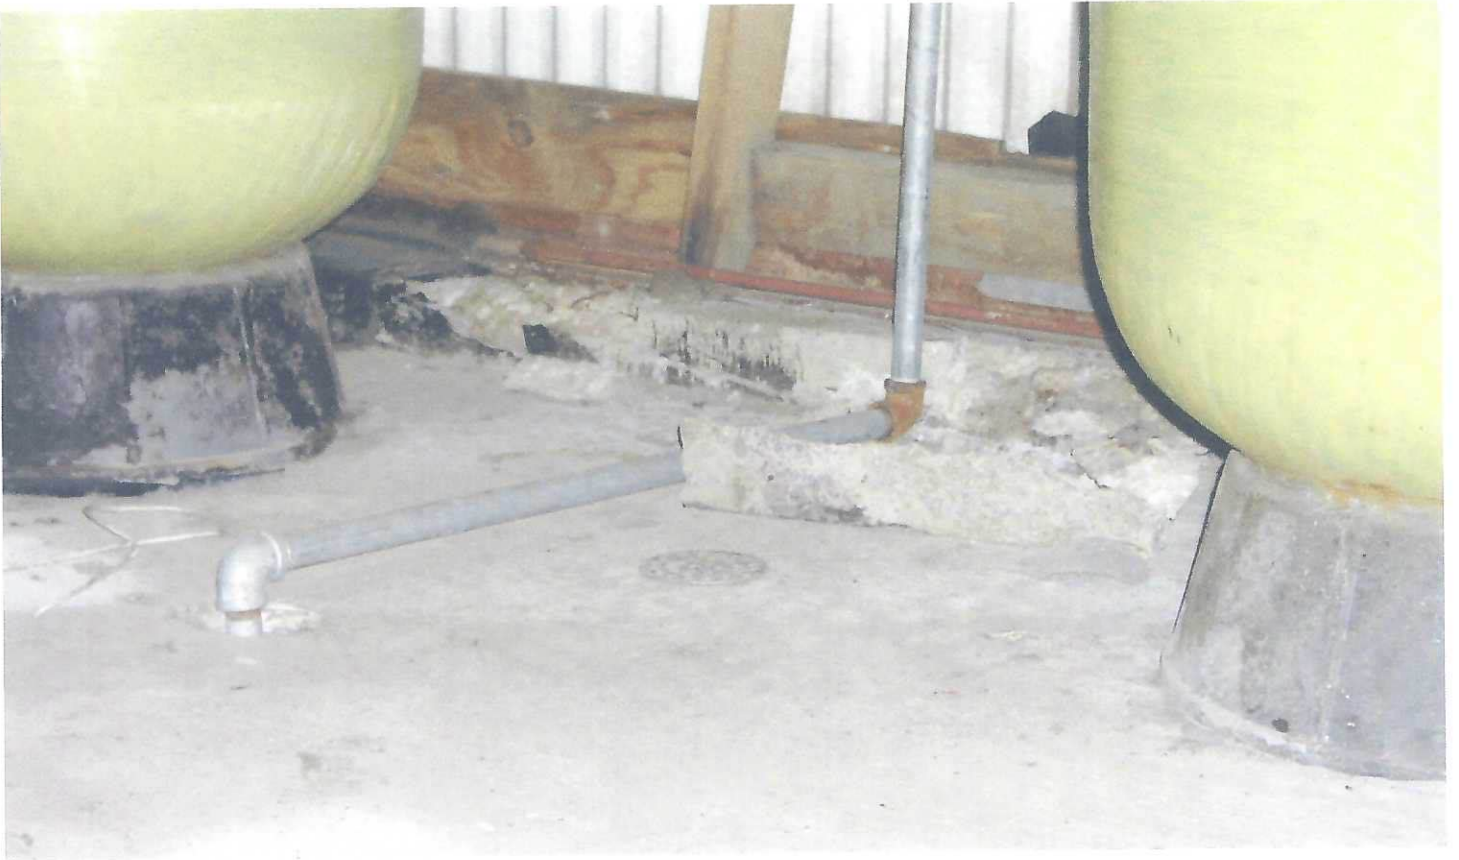
2. The new slab was cast against the existing concrete curb with no apparent special treatment of the interface. We noted that the curb was significantly fractured, apparently as a result of the salt penetration. Pieces of the concrete could be lifted off by hand. (*Fig. 3*)

Fig. 3 - Deteriorated Curb at Water Softener

- a. Relocate certain equipment in the mechanical penthouse.
- b. Remove the new concrete slab at the water softener, and remove damaged portions of the penthouse curb.
- c. Temporarily support mechanical piping and HVAC equipment in the ceiling space below the slab.
- d. Demolish and dispose of approximately 350-400 SF of existing roof slab, leaving the beams and steel penthouse framing intact.
- e. Install concrete forms and cast new portions of the roof slab.
- f. Reinstall mechanical equipment and add permanent supports in the ceiling space.

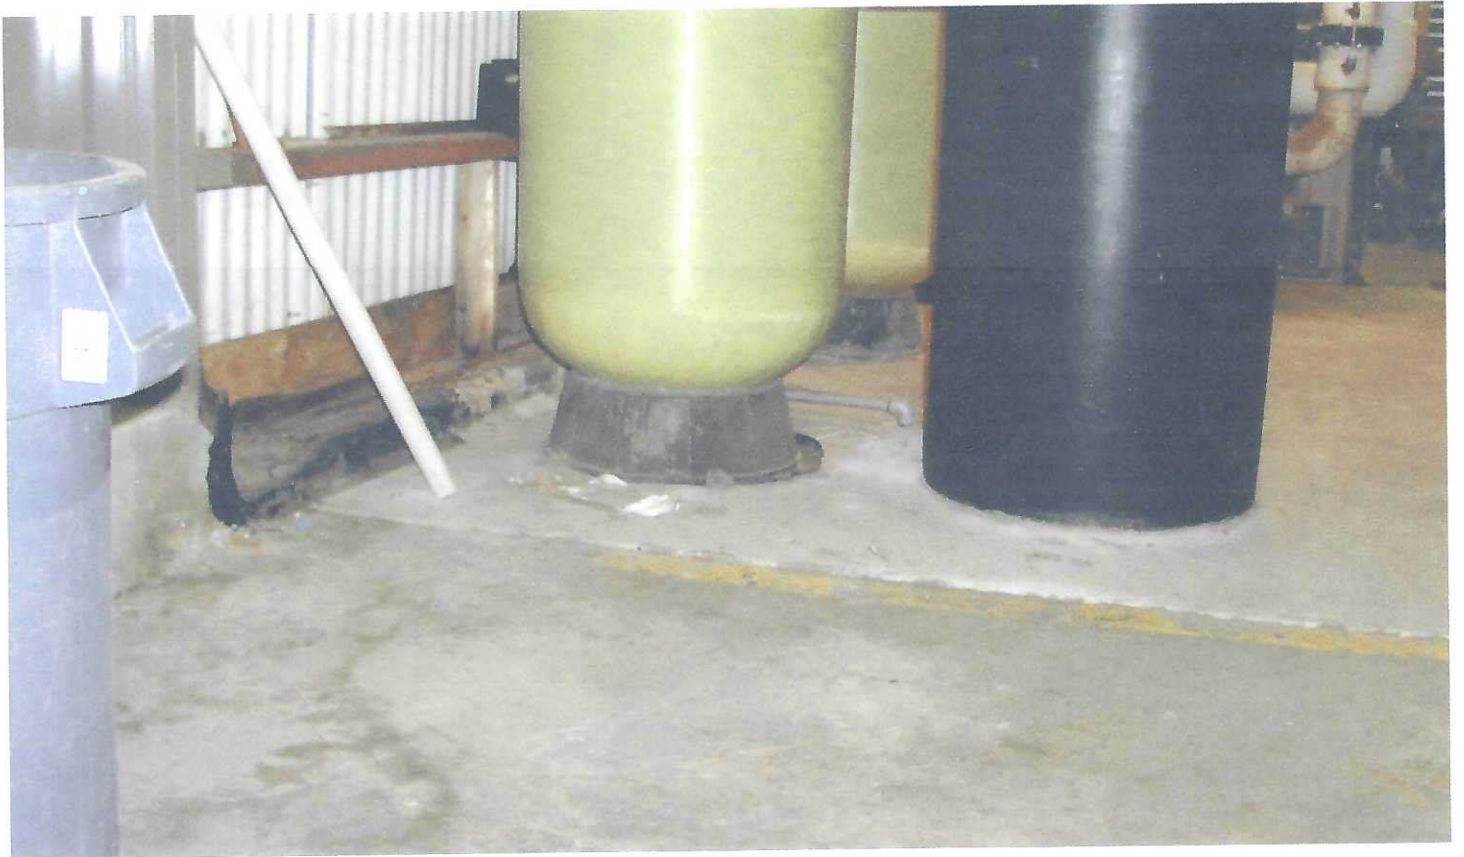
3. Casting the new slab at the water softener served an immediate purpose of providing a new working surface, but the damage by salt penetration into the concrete was not stopped. It is also our opinion that water is still able to penetrate through the interface between the new and old concrete, thereby keeping the corrosion process active.

Fig. 4 - Equipment Slab in Mechanical Penthouse

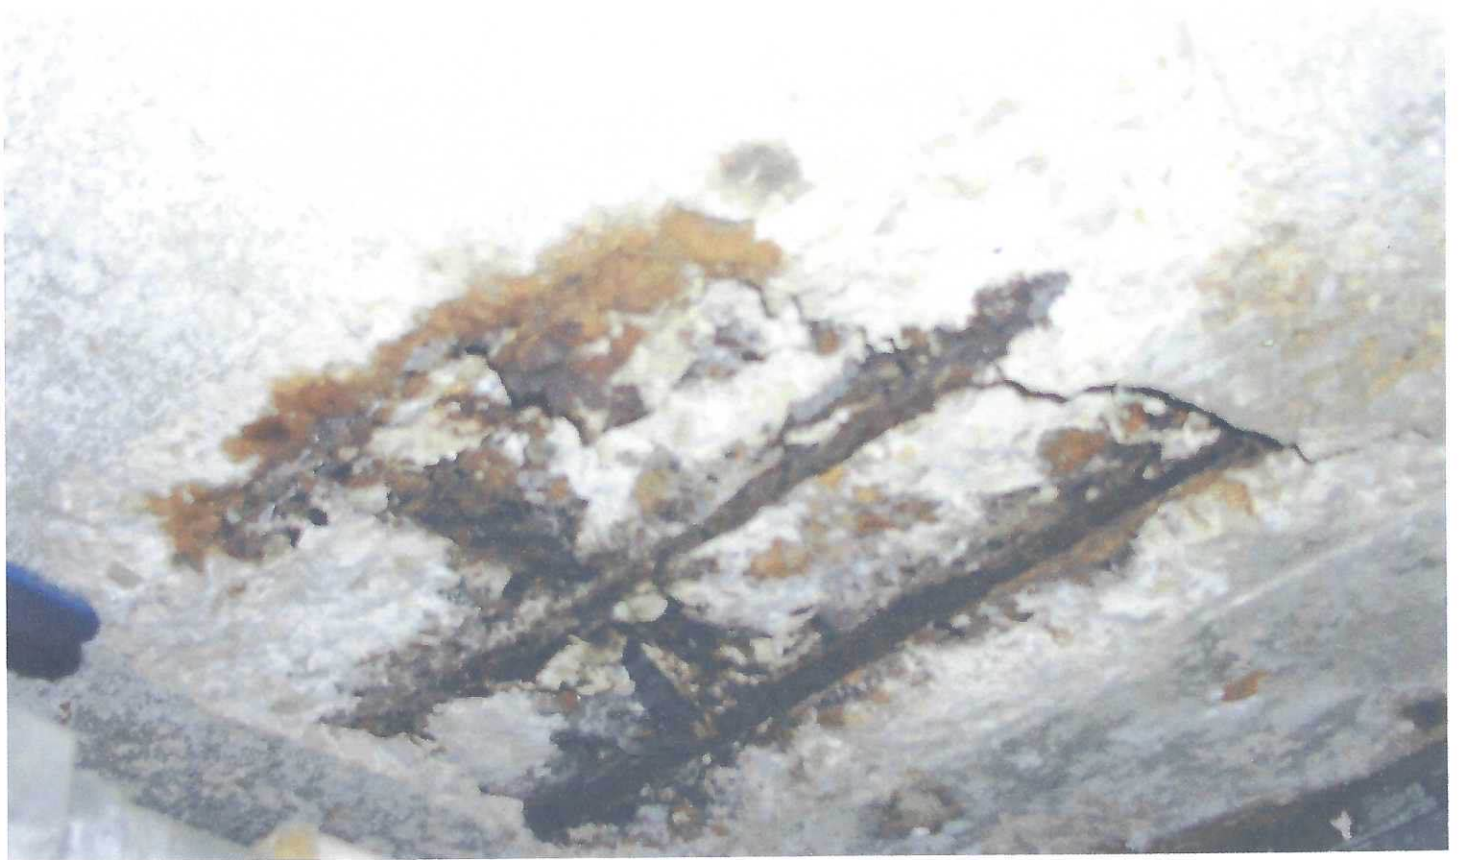
3. At the underside of the roof slab in the area of the water softener, several areas of corrosion were noted. In addition, spalling of the concrete surface was evident. (*Figs. 5 & 6*) Large sections of the concrete could be removed with a small tool, exposing corroded reinforcing steel. Some of the light gage steel wall framing was also noted to be corroded, possibly requiring replacement.

1. It is our judgment that the observed corrosion and spalling of the roof slab was caused by the intrusion of sodium chloride salt into the slab. This was most likely the result of years of spilling salt onto the slab surface above, followed by moisture condensation and/or rainwater penetration which dissolved the salt.

Fig. 5 - Spalled Concrete on Underside of Roof Slab

**Method A:** *Remove the damaged portions of the roof slab and replace with new concrete and reinforcing steel.*

**Method B:** *Add a new concrete slab on top of the existing slab, with adequate reinforcing to support the existing slab and equipment.*

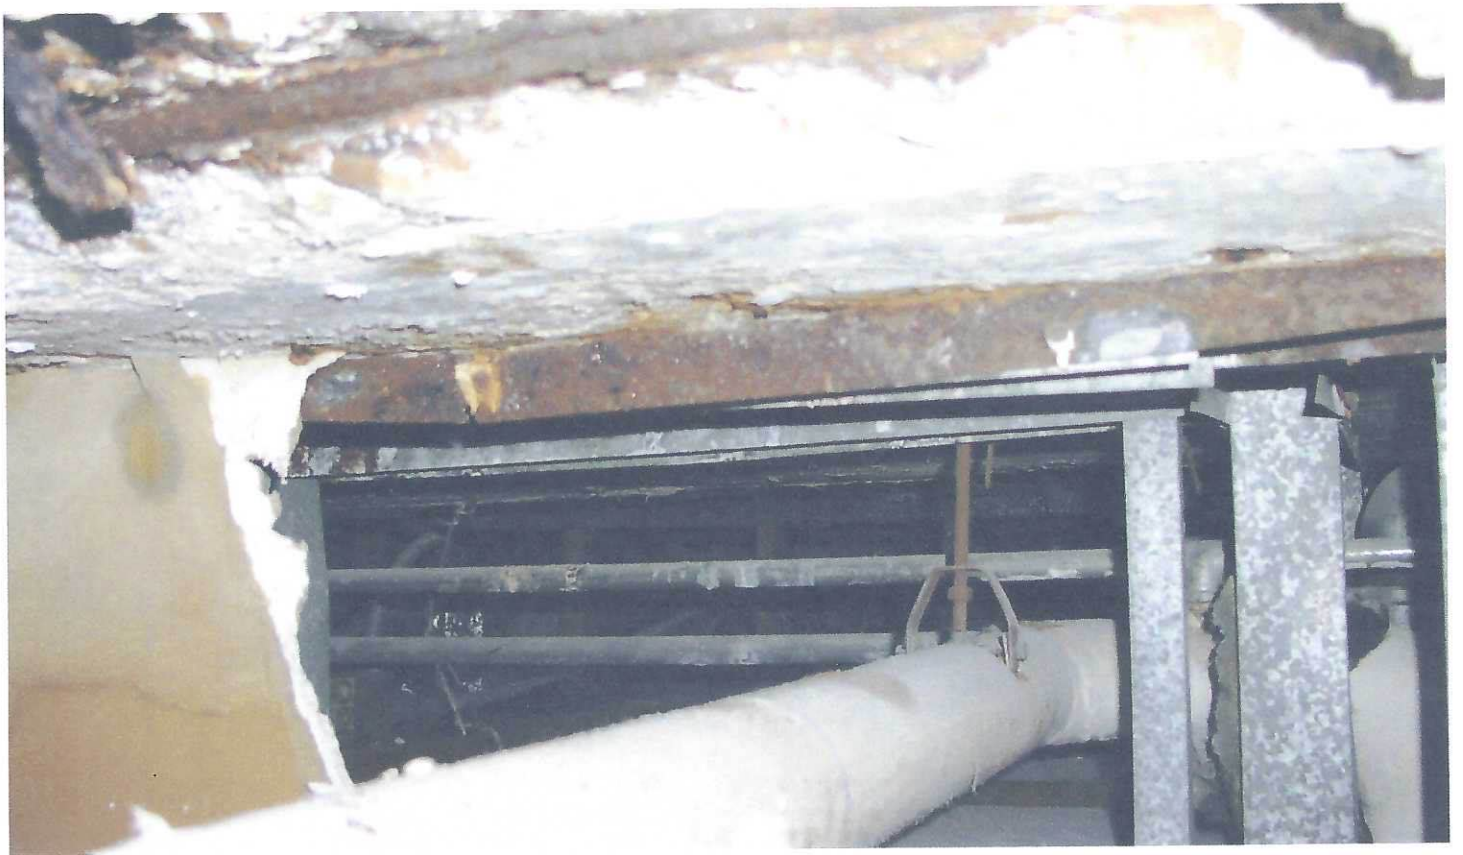
Fig. 6 - Corrosion and Spalling Under Water Softener

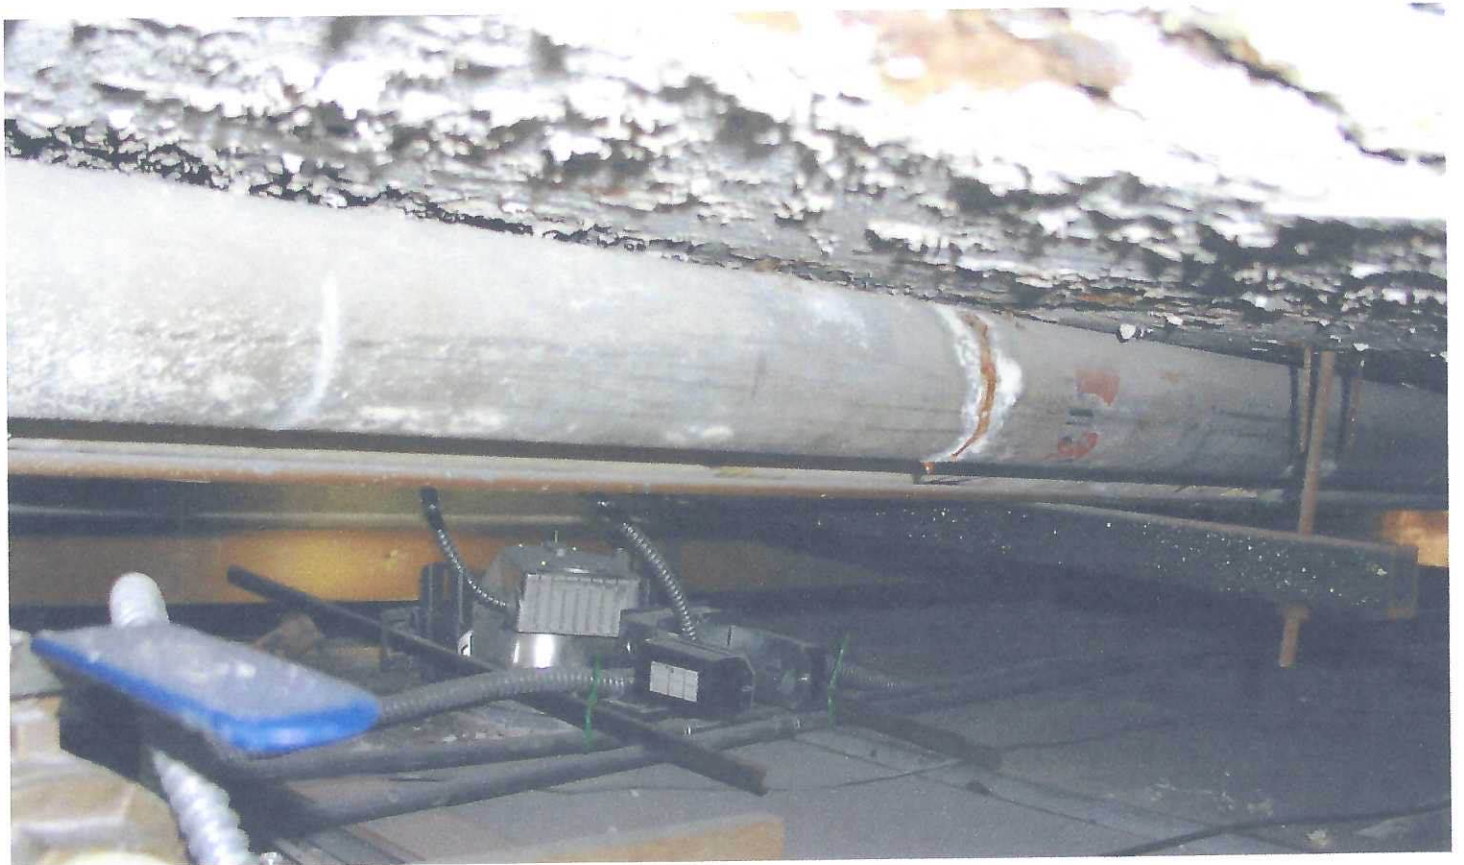
4. A buildup of chemicals leached out of the concrete was visible over approximately 250-350 SF of the slab. These areas were apparently the result of water penetrating the 8-inch slab and leaching out chemicals and salts. They indicate a fairly large extent of chemical activity. (*Fig. 7*)

Fig. 7 - Leaching of Salts Through Roof Slab

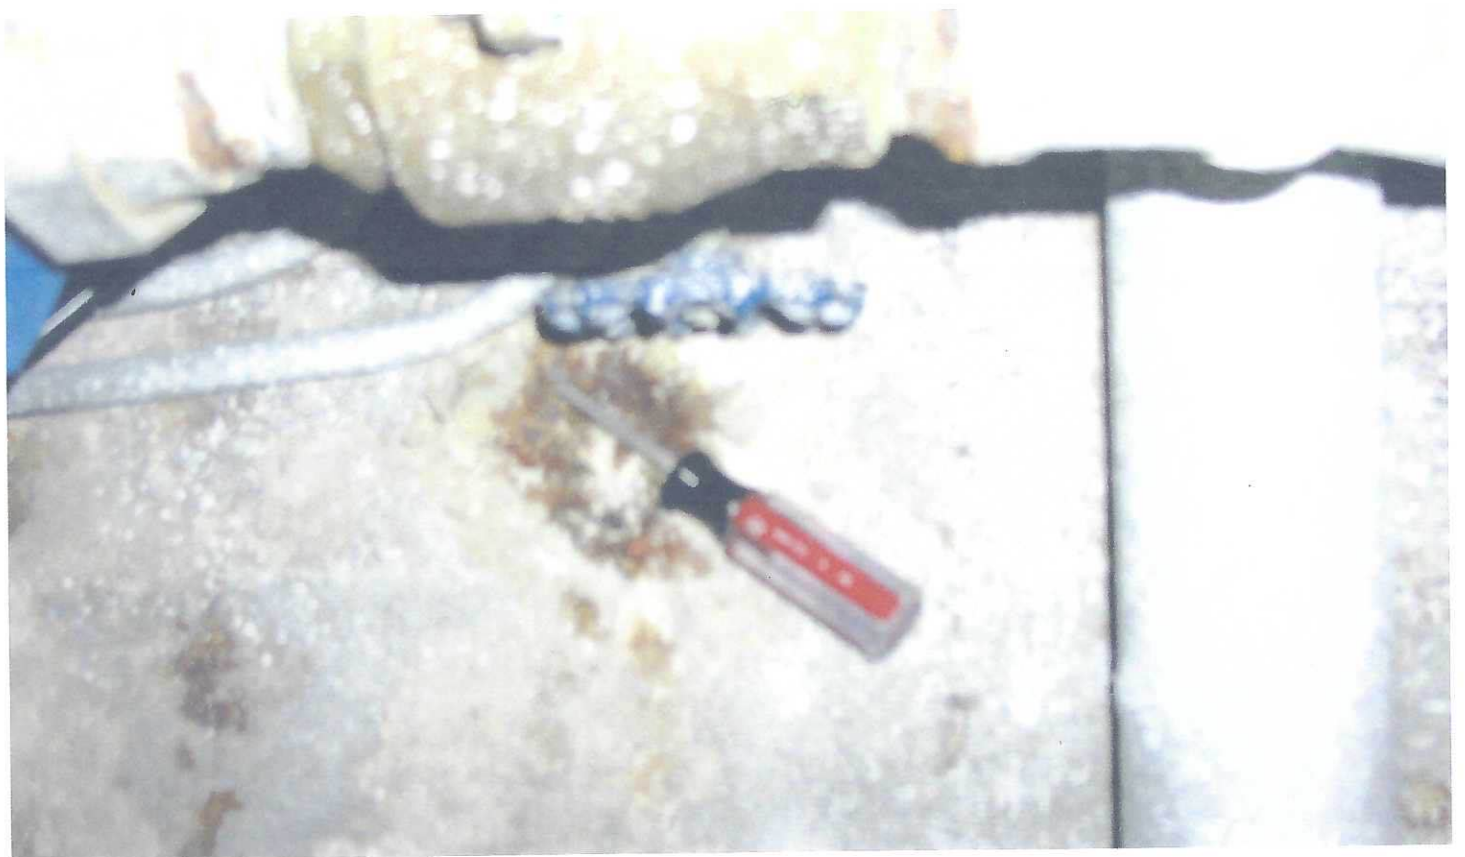
5. Spalling was noted in several areas where the concrete had separated from the reinforcing and was suspended in place. We were able to slide a screwdriver several inches into the separations. In other areas, the separated concrete could be removed by hand. (*Figs. 8, 9, & 10*)

Fig. 8 - Developing Spall Underneath Roof Slab

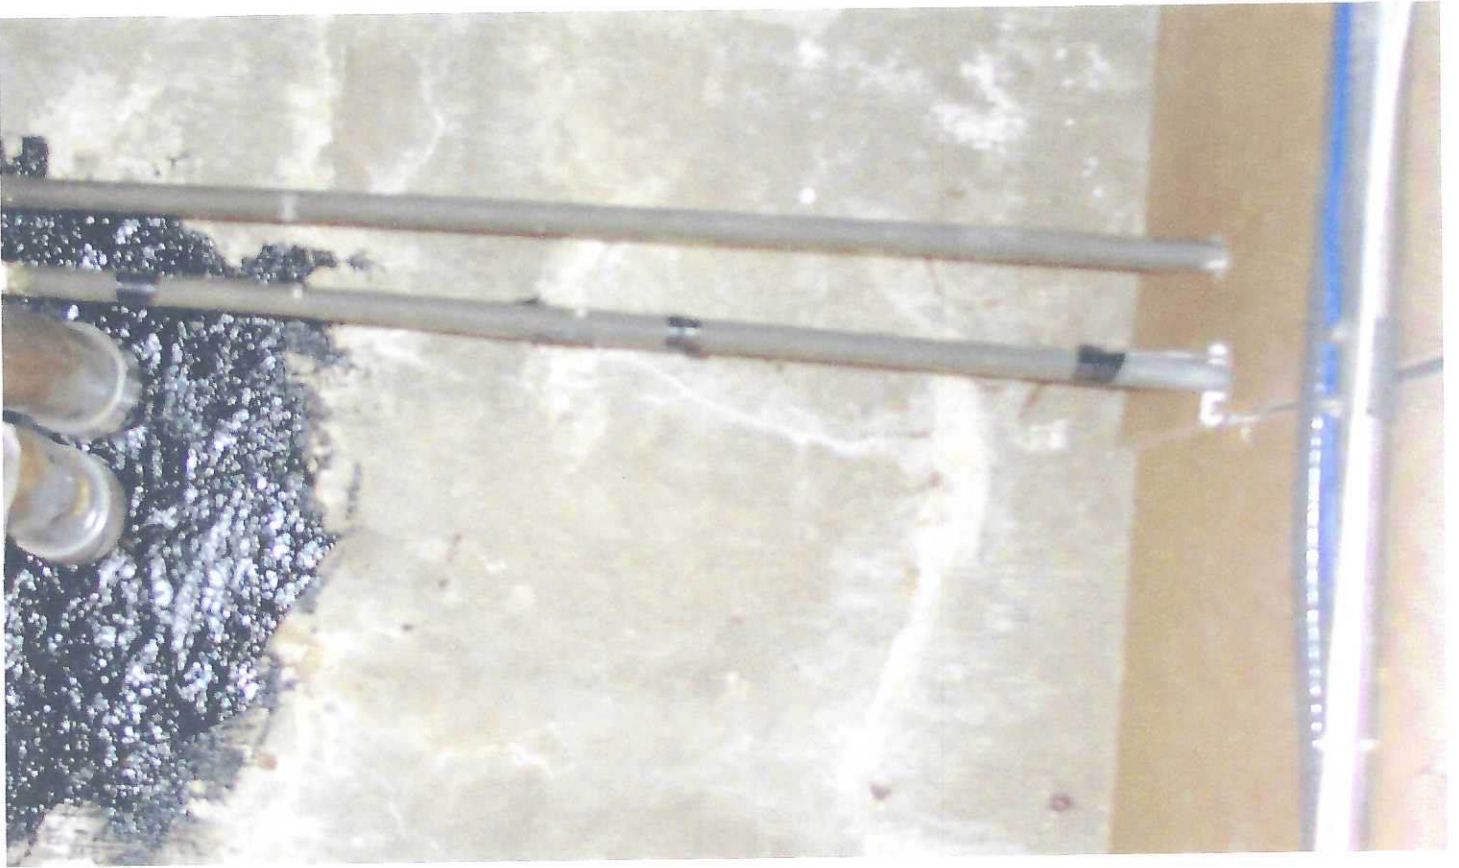
Fig. 9 - Roof Slab Above Electrical Equipment Room

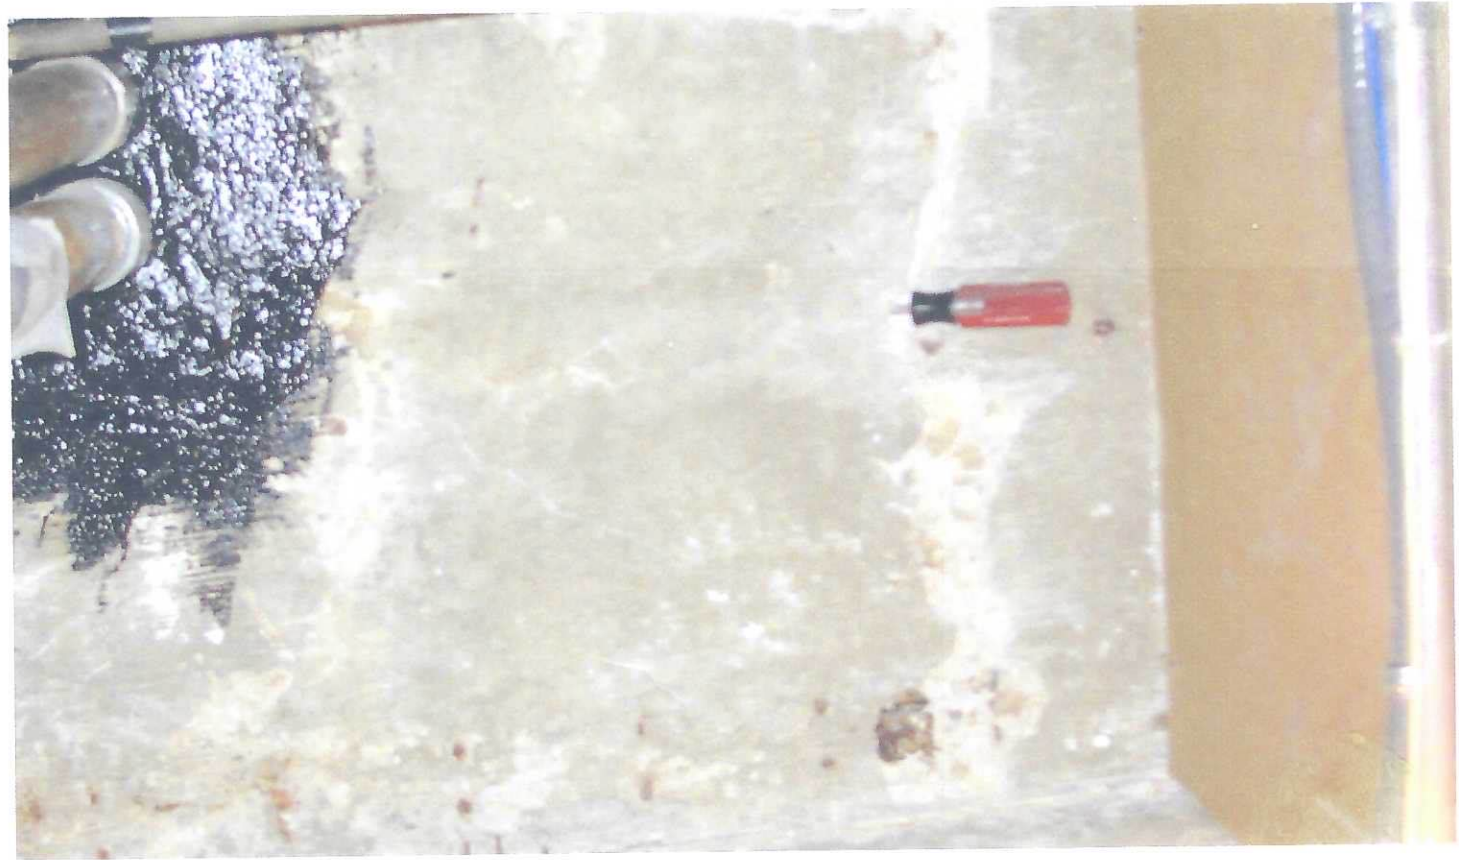
Fig. 10 - Developing Spall Above Electrical Equipment

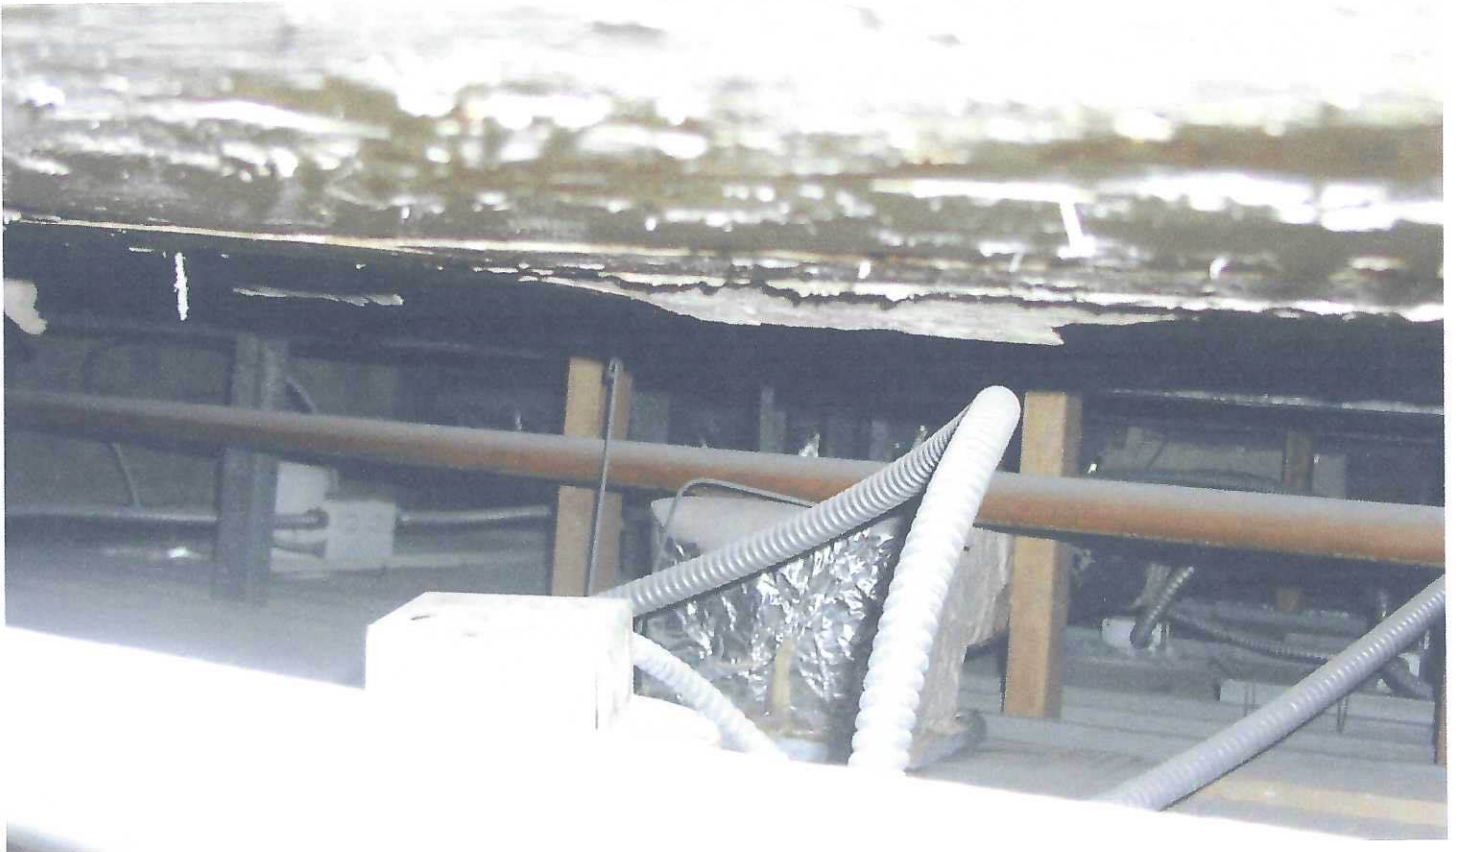
6. The corrosion and spalling was noted to extend over the hallway and the adjacent residence. We found that visible evidence terminated within approximately 20-ft either side of the elevator doors, but additional laboratory testing will be need to determine the full extent. (*Figs 11 & 12*)

Fig. 11 - Leaching and Spalling of Roof Slab

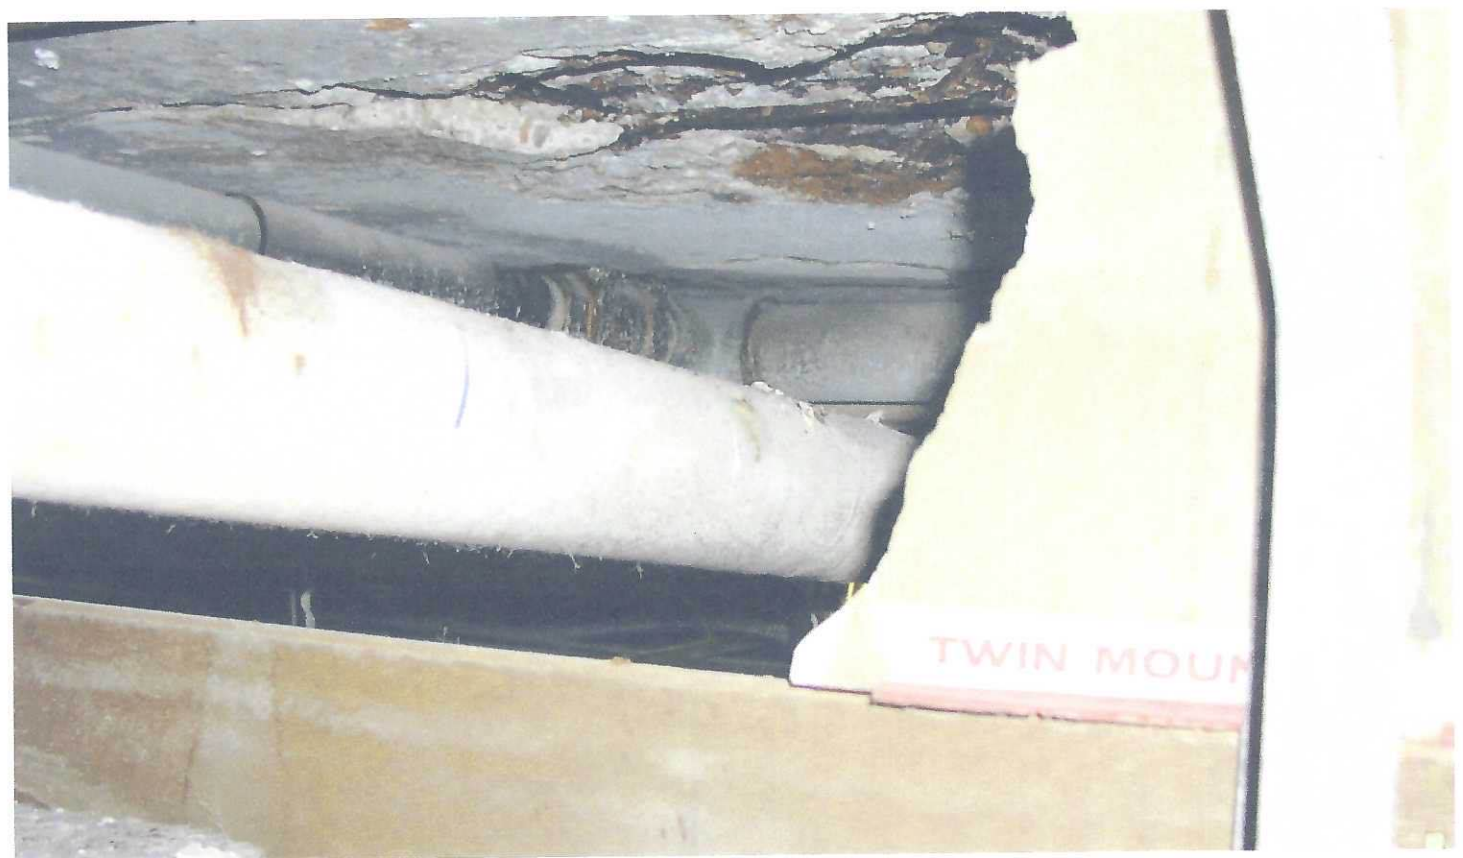
Fig. 12 - Spalled Concrete and Corrosion of Roof Slab

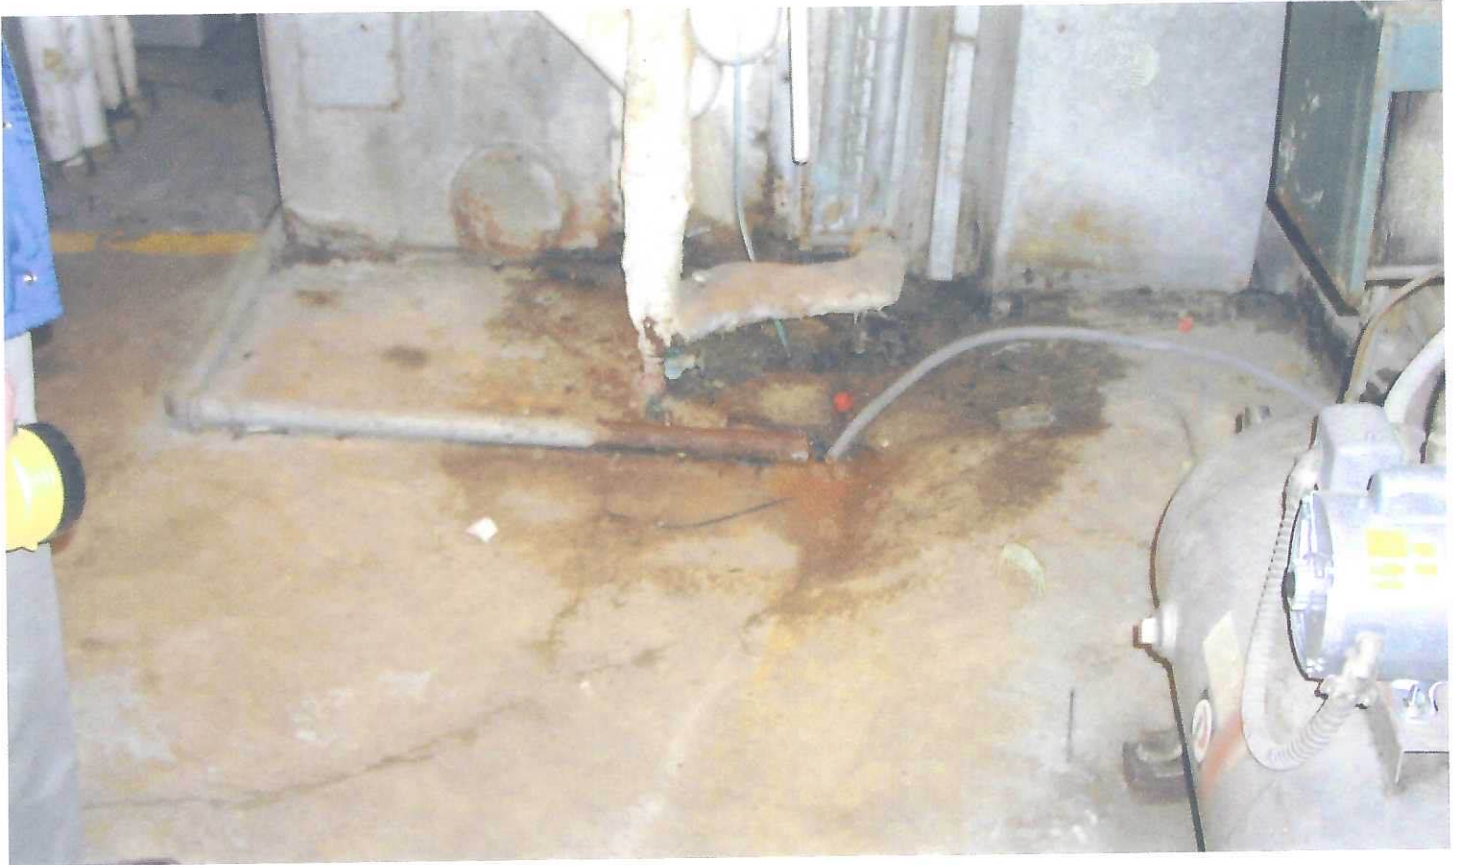
8. Within the mechanical penthouse, we noted significant corrosion at the floor drain on the westerly end. (*Figs. 13 & 14*) This drain apparently is meant to handle condensate

drainage for several pieces of the mechanical equipment, since there are at least four lines terminating at the drain. Each of the lines discharge directly onto the floor surface instead of into the drain; we anticipate this will soon become a maintenance problem.

Fig. 13 - Floor Drain Near Mechanical Equipment

4. Replace all condensate lines and the floor drain at the westerly end of the mechanical penthouse.
5. Provide for adequate floor drainage around the mechanical equipment to prevent standing water or moisture penetration.

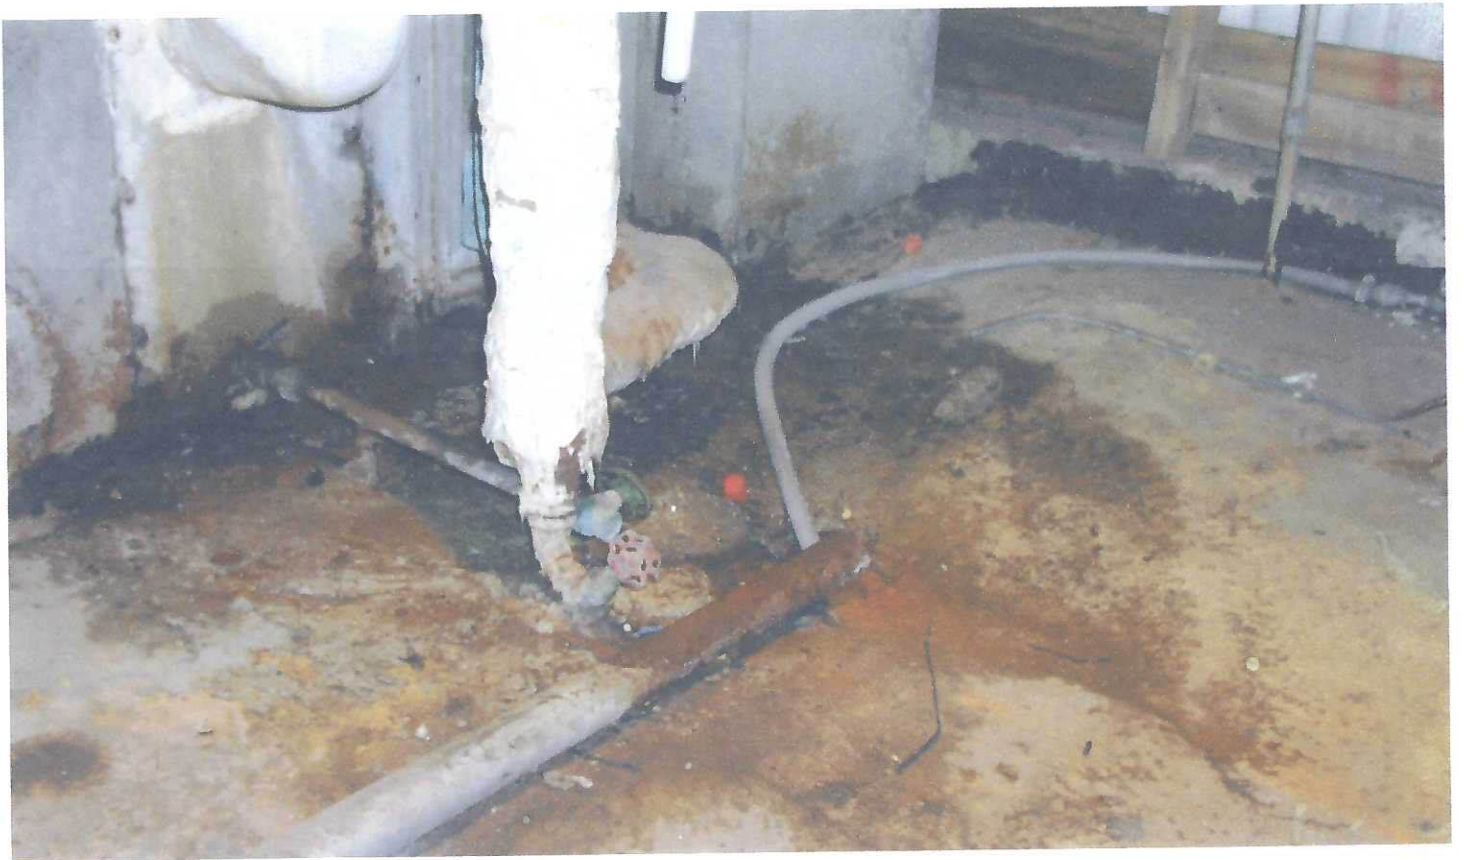
Fig. 14 - Detail of Floor Drain

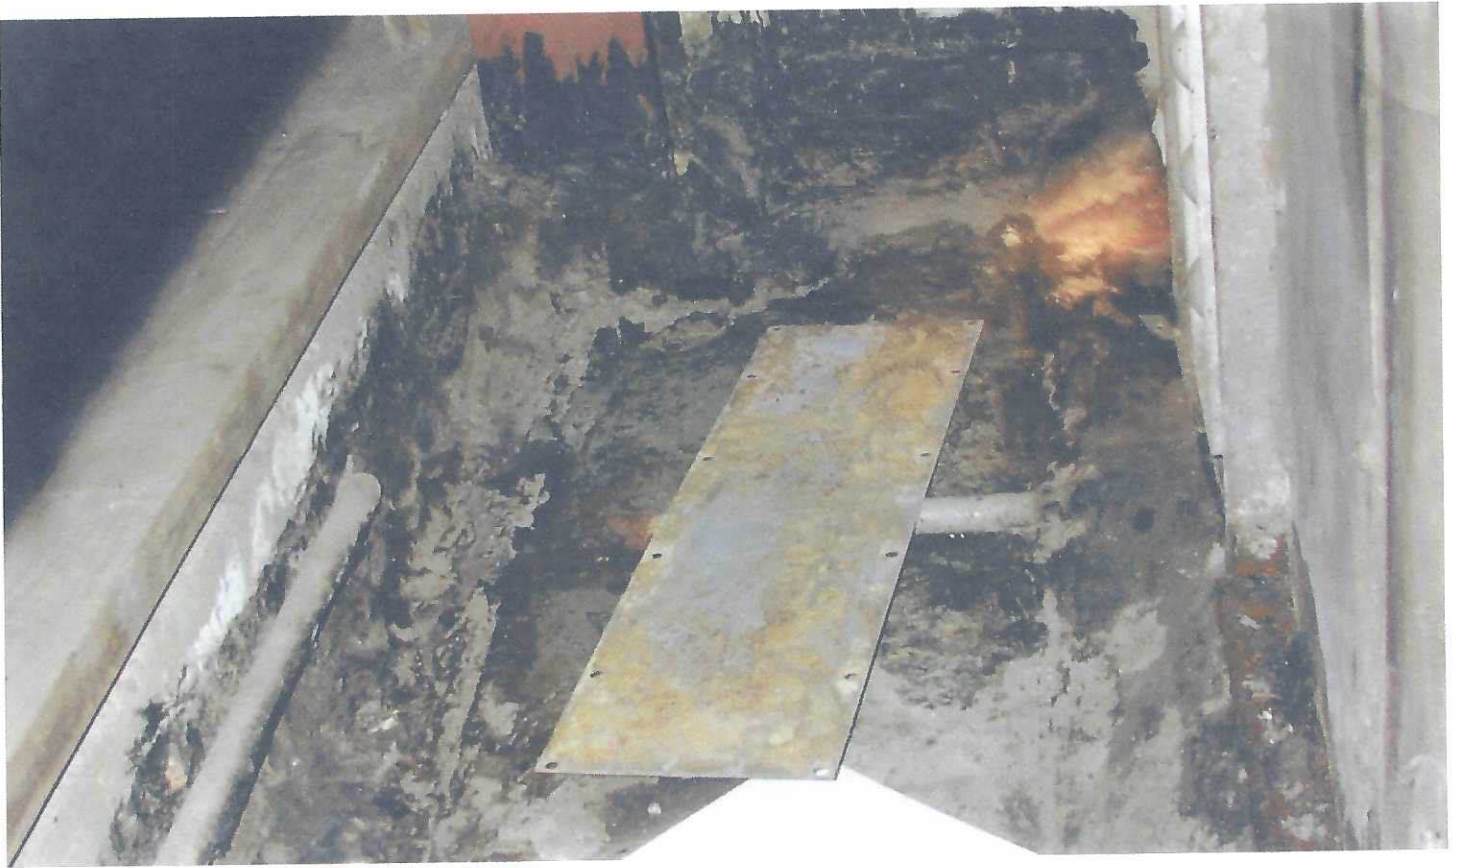
9. We noted that the floor area on the western side of the penthouse appears to inadequately drain and may introduce additional maintenance concerns. (*Fig. 15*)

Fig. 15 - Floor Condition at Air Intake
